## Coal Mine Fatal Accident 2005-09

Operator:	Rosebud Mining Co
Mine:	Tracy Lynne
Accident Date:	June 10, 2005
Classification:	Roof fall
Location:	Dist. 2, Armstrong County, Pennsylvania
Mine Type:	Underground
Employment:	33
Production:	1,660 tons/day

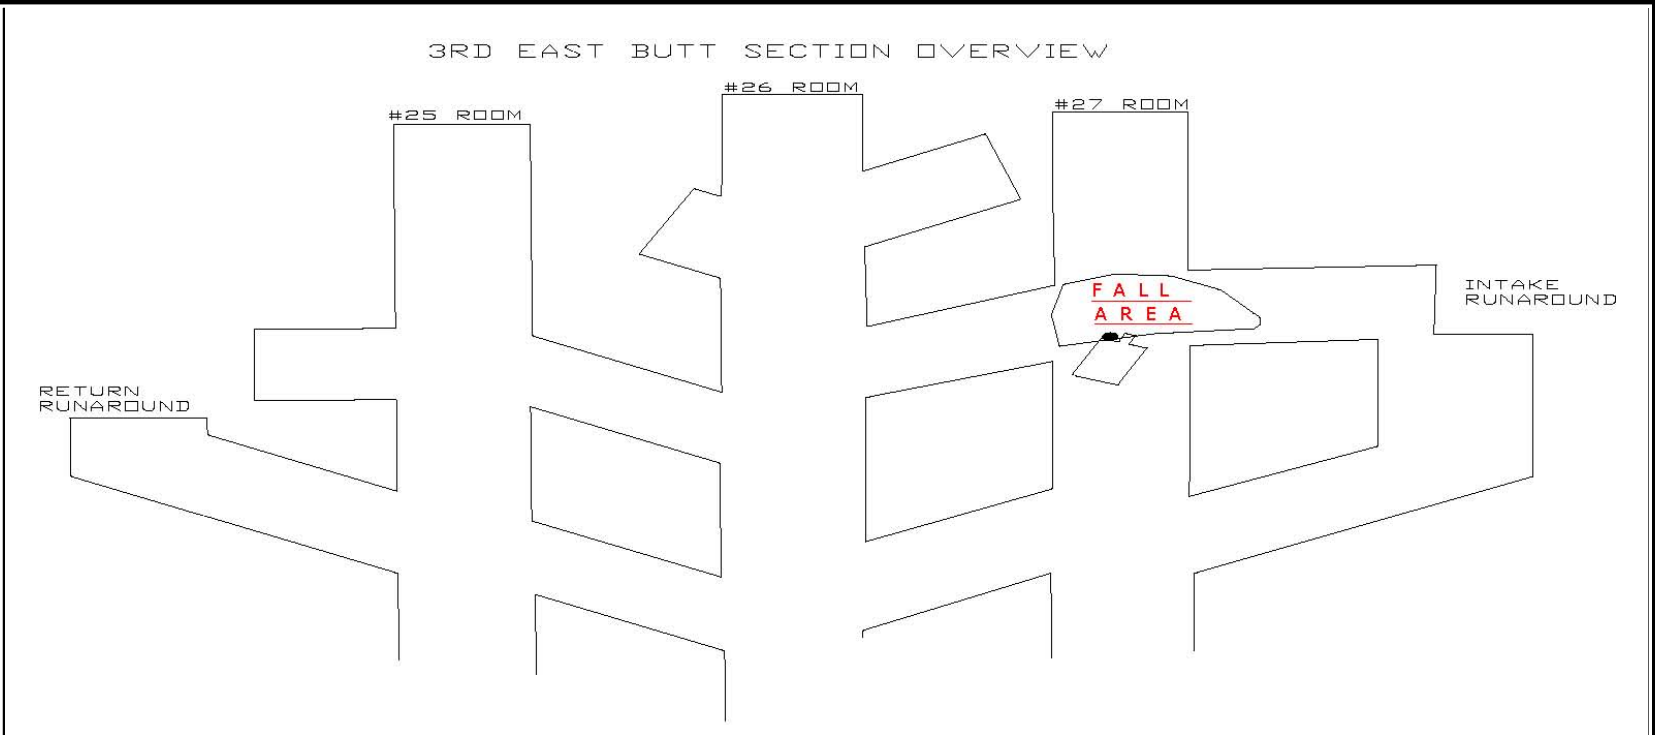
On June 10, 2005, the afternoon section foreman entered the mine at approximately 2:00 p.m., traveled to the section, and discussed general section conditions with the day shift section foreman. Everything was reported to be normal. The afternoon shift crew consisting of nine persons entered the mine at 2:30 p.m. While conducting routine examinations of the working section, the afternoon section foreman observed a defect in the roof strata in the No. 27 intersection. He tested the roof and checked an approximately 51 inch test hole and found no separations or indications of loose roof.

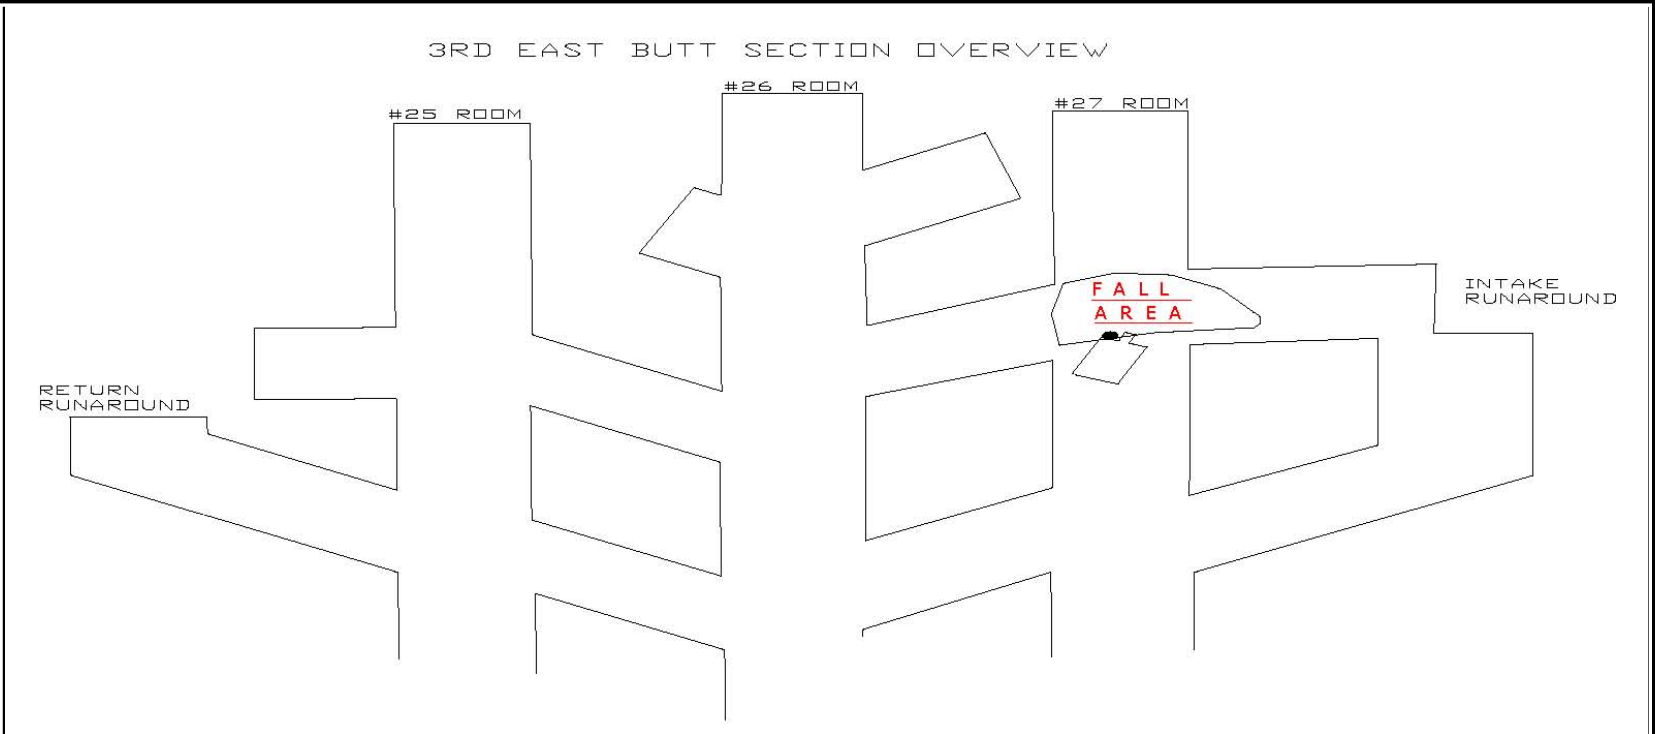
The crosscut from 27 Room to the intake runaround room was mined to a depth approximately 35 feet creating a 9-foot opening into the intake runaround. After mining was complete, the victim began to support the newly exposed roof using 36-inch resin grouted bolts. After installing three roof bolts, he reported to the section foreman that he had drilled a test hole in the No. 26 room (belt) and had detected a separation in the roof at approximately five feet in depth. The foreman instructed the victim to back up and start installing 6-foot bolts, which he did.

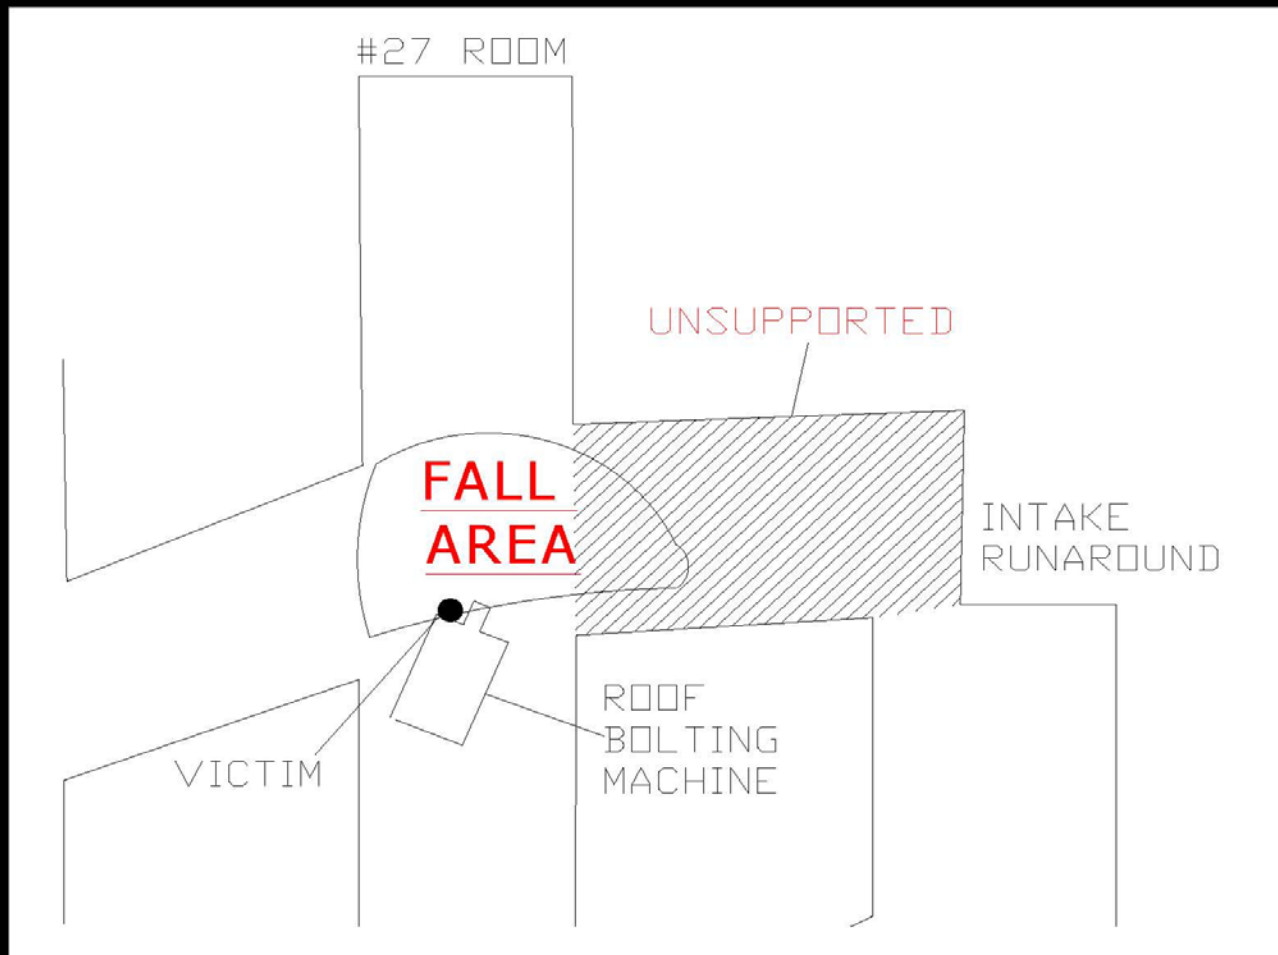
The foreman was in the No. 26 room when he heard a noise that sounded similar to the sudden dropping of a scoop bucket onto the mine floor. He immediately traveled to the intersection of the No. 27 room, where he discovered a roof fall that had fallen on the victim and had covered the front and left side of the roof bolting machine.

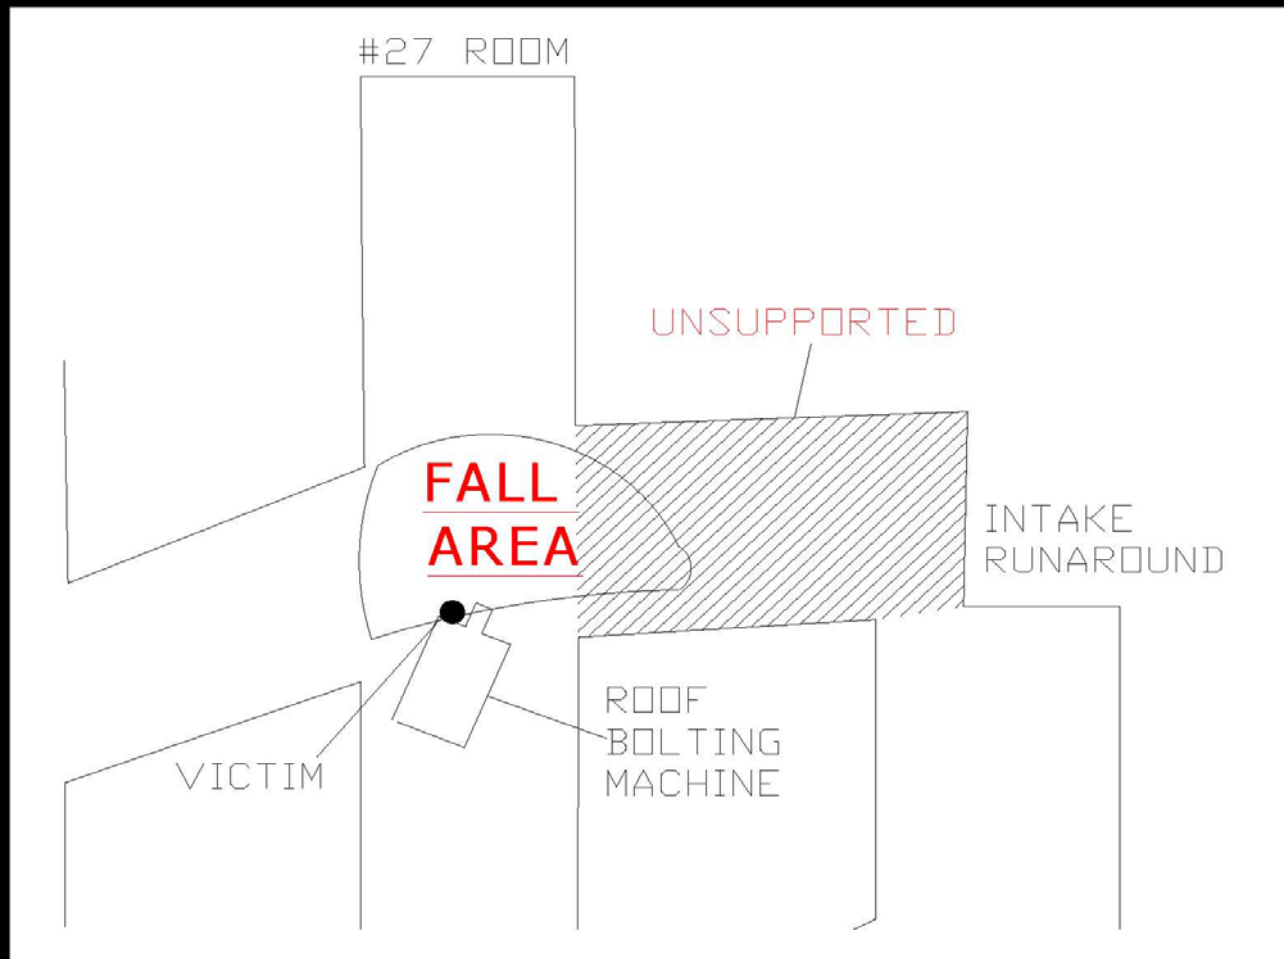
**METHOD OF MINING** - The section contained room centers of 65 feet, and crosscut centers of 60 feet, resulted in pillar sizes of roughly 45 feet by 40 feet. When the deep cut was mined approximately 35 feet in the crosscut from the No. 27 room intersection into the intake runaround room by the afternoon shift, a 4-way intersection was created.

*Causal Factor:* The standards, policies, and administrative controls in use at the mine did not ensure that deep cuts were not taken off of areas where defective roof exists. A deep cut was taken from the 3-way intersection in No. 27 Room to the intake runaround which also created a 4-way intersection in the area of the roof defect.

*Corrective Action:* The roof control plan was reviewed and explained to all employees prior to mining being resumed. Special emphasis was also placed on the importance of limiting cut depth adjacent to areas with defective roof conditions.

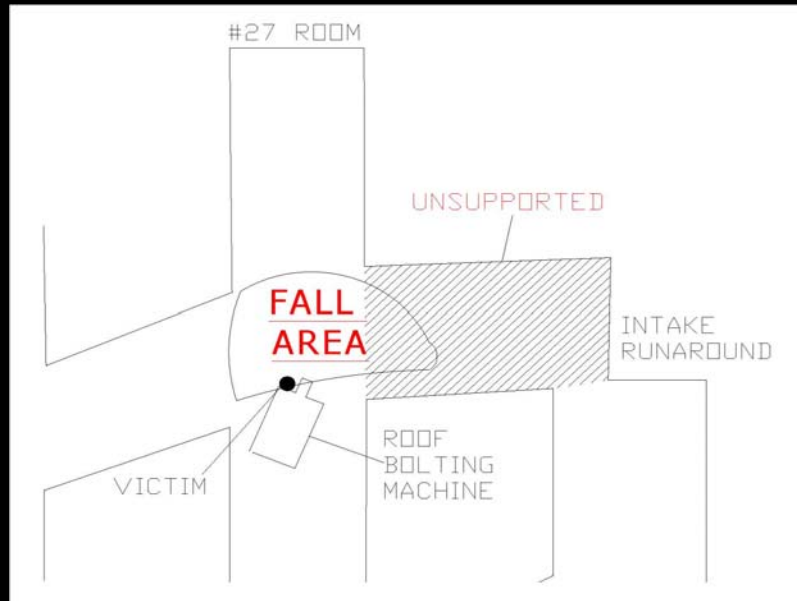
**GEOLOGIC CONDITIONS** - The immediate roof generally consisted of gray shale ranging in thickness to 20 feet. However, as observed in the general vicinity of the accident site, the roof fall was sharply defined by two intersecting slickenside zones. The first slickenside zone represents a "drag fold" that was traced across the entire mining section, from the intake runaround, through rooms 25-27. The 2nd slickenside zone represents a fault. Where the two zones intersect, a large wedge (commonly referred to as a horseback) was defined above the 27 room intersection. The roof fall cavity formed when the wedge dropped out of the roof onto the victim. The triangular-shaped wedge, was approximately 26 feet long, 15 feet to 13 feet in width, and from five feet to less than one foot in height. The roof fall material was estimated to weigh approximately 39 tons.

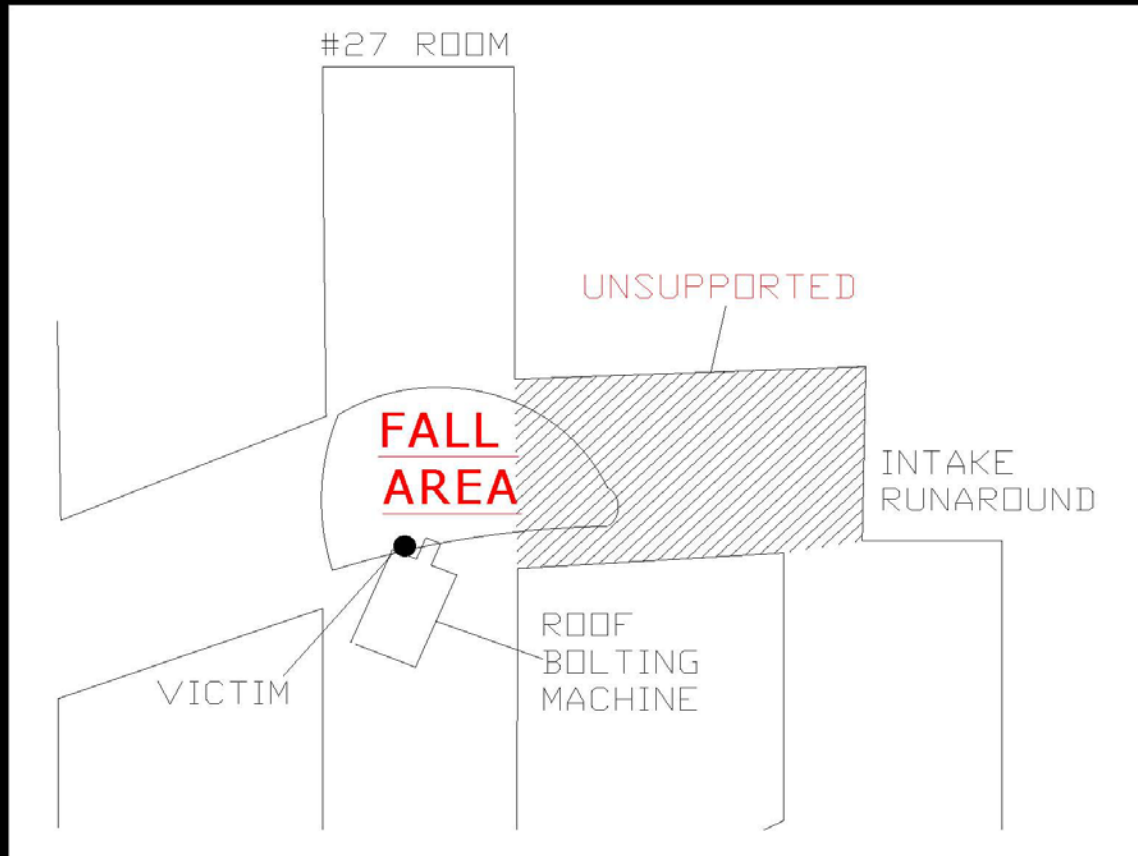
**ROOF CONTROL PRACTICES** - The No. 27 room intersection (3-way) was originally mined by the daylight shift, on June 10, 2005. A visual roof defect was observed and a test hole drilled in the intersection which did not show any separations in the roof strata. The entire intersection was supported, utilizing 36-inch resin grouted roof bolts. The mine roof on the section was typically supported with 36-inch, fully grouted resin roof bolts, installed on a 4-foot crosswise by 4-foot lengthwise pattern.

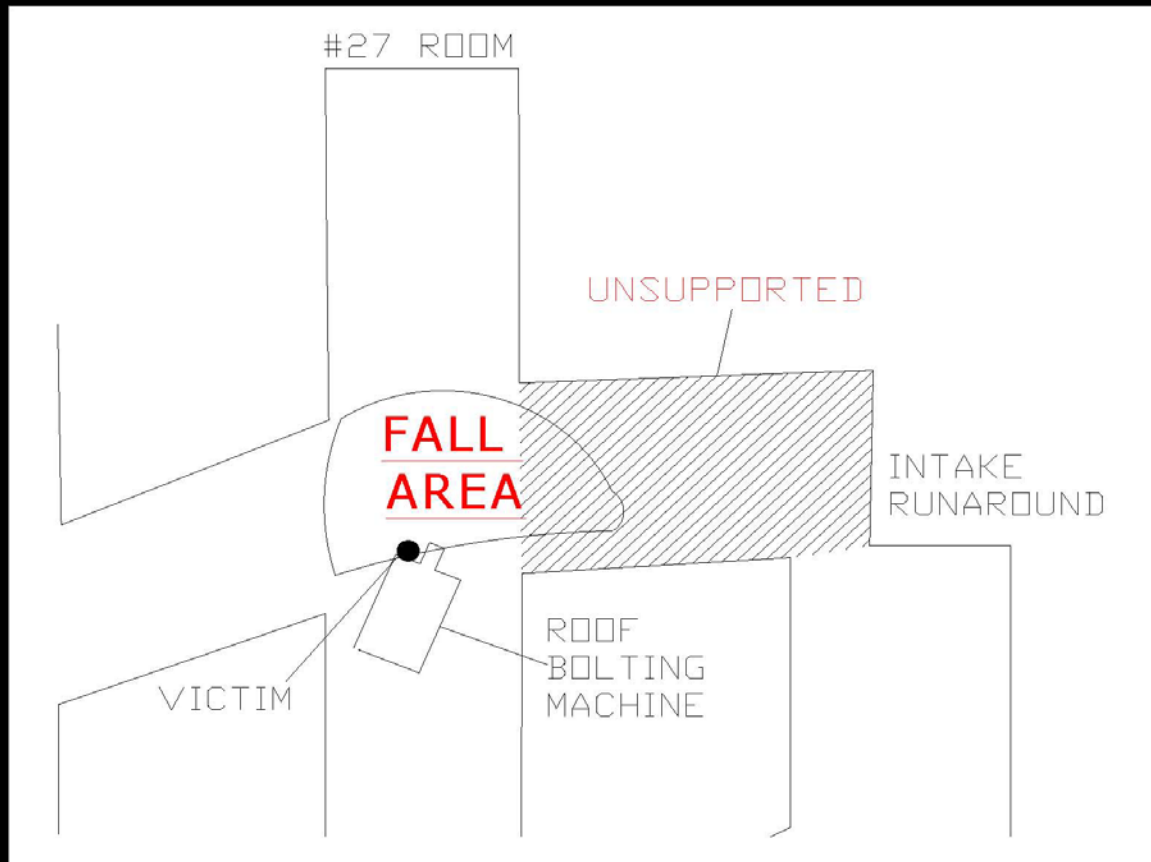
**ROOF CONTROL PRACTICES Continued** - Interviews with both day and afternoon shift production crew members indicated that a visual roof defect which was inconsistent with normal roof conditions was recognized in the Nos. 25, 26 and 27 Rooms which was generally similar in size and magnitude. The condition was recognized as an area that required additional precautions in the Nos. 25 and 26 Rooms based on the fact that 42 and 72-inch supplemental support roof bolts were installed and the depth of cut was limited.

*Causal Factor:* The standards, policies, and administrative controls in use at the mine did not ensure that supplemental roof supports were installed according to the approved roof control when a visual defect in the roof was evident.

*Corrective Action:* The roof control plan was reviewed and explained to all employees prior to mining being resumed. Special emphasis was placed on recognizing hazards and roof defects in the roof in conjunction with the importance of installing supplemental roof supports according to the approved roof control plan.
